## **D. Hull, Deck and Structure**

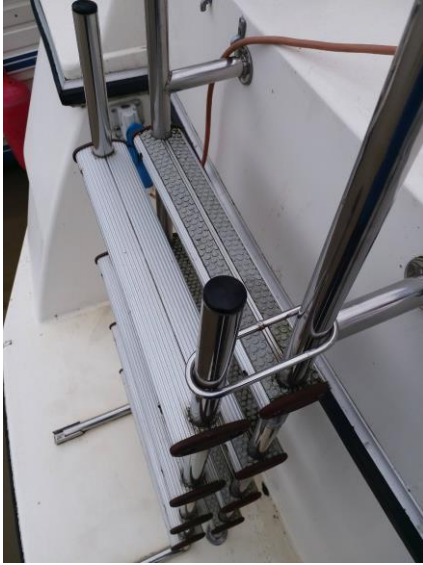
There is a GRP constructed bathing platform complete with stainless steel ladder and extension ladder. When the platform took my body weight; it didn't move or warp. See Fig.1.

Fig 1 – Integrated Transom bathing platform.

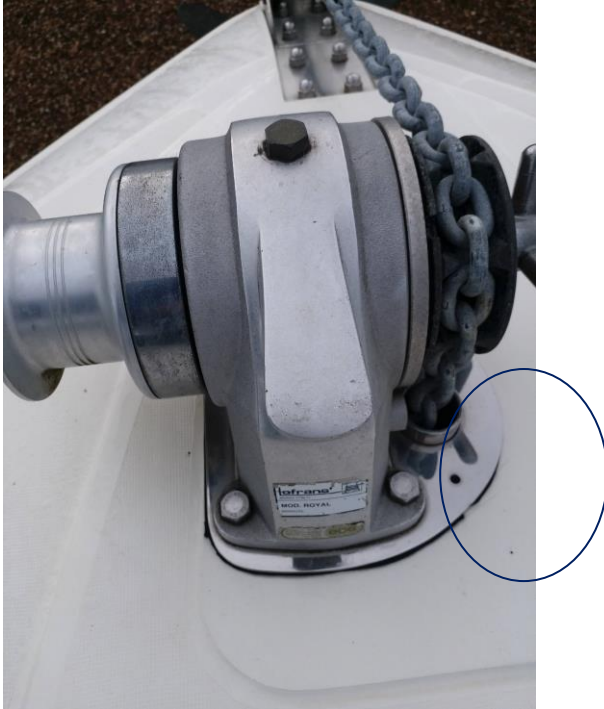
The deck moulding horizontal surfaces appears in decent condition no visible sign of water ingress was observed. Light hammer testing was conducted to check for de-lamination and de-bonding. No sponginess was detected. The Tramex Moisture reader was used to take readings using the GRP setting on the meter. Near the windlass on the starboard aft area reading were in the range of 80 plus and set off the audible alarm on the Tramex device. When the anchor locker was checked it was observed a GRP repair had been done previously and after light hammer tapping revealed there may be some de-lamination probably after water ingress had occurred via the windlass deck chain hole and penetrated the core. Fig.2

Moisture Meter Readings	Range
Tramex Skipper Plus, Comparative (GRP) 0-100, where Zero is "dry" and 100 considered "high moisture".	
Deck Moulding -bows, port and starboard lateral areas	20-32

Fig 2. xxxxxx xxxxxxxx windlass with high moisture readings indicated by blue circular outline.

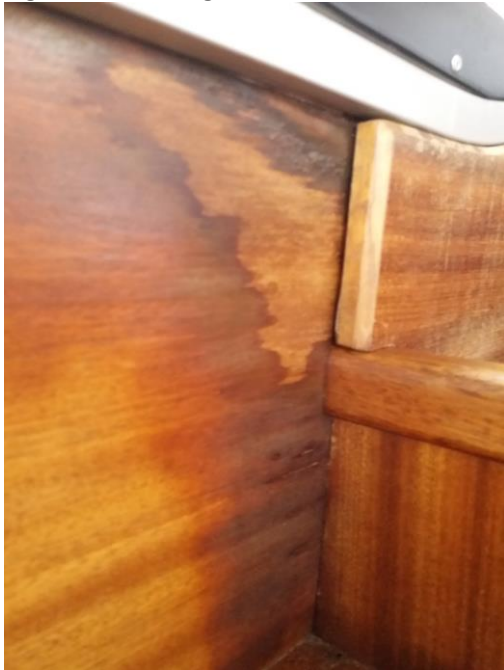
Signs of water ingress was located on the starboard side aft window where it meets the brace. Fig 4

Fig 4 - Signs of previous water ingress
